STS-107 Columbia Reconstruction Report

NSTS-60501

JUNE 30, 2003

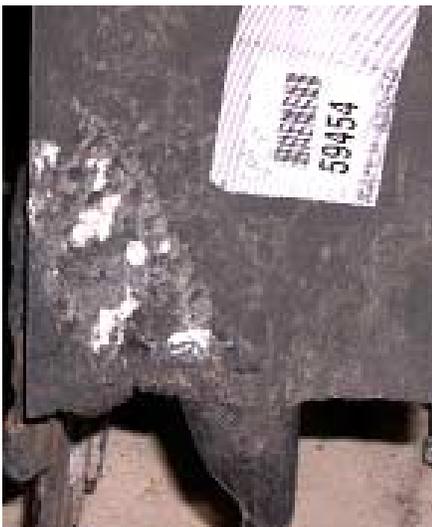
Item 59454

Right hand gap Seal 13 lower portion has tile material on the outer surface of the seal (59454).

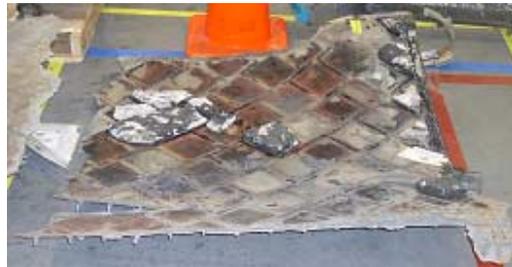
Item 35834

These items included the right hand and left hand ET door, two large skin pieces (35834, 76544) on each side of the vehicle centerline, and a portion of the lower Xo1307 bulkhead. The recovered pieces of structure on the left hand side have more heat related effects than those on the right hand side, except for the internal thrust structure items of high ballistic coefficient. Numerous tiles were identified as possible aft tiles; however, their final location was not determined due established priorities. The only tiles that were assessed were on the largest of the recovered pieces. The exposed filler bar/remnants were more charred on the left hand recovered pieces than the right hand.

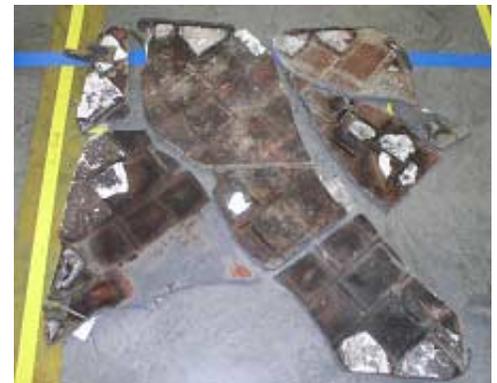
LH ET Door

The right hand ET door (53830) is fully intact with fracture edges at each of the two hinge points. Approximately sixty percent of the tile is still bonded. The OML surface and the primer on the IML of the door is not discolored. In comparison, seventy-five percent of the left hand ET door was recovered, in seven pieces, and has only five percent of the tile fragments attached. Two large floor skin pieces recovered accounted for nearly the entire area between the left hand and right hand ET doors. The right hand piece (76544)

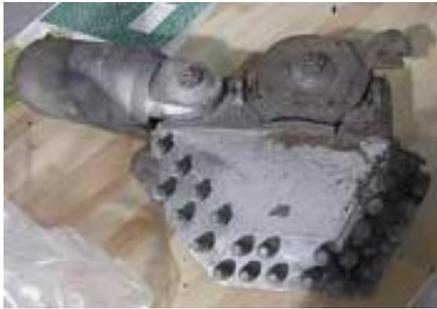
Item 1181

Four additional recovered pieces of primary structure each having heavy thermal erosion and melting on the edges are a thrust structure strut, beam, and strut attach points (36055, 42928, 1181, 24846).

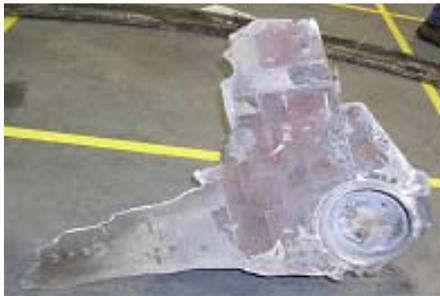
Item 49366

The RH sidewall hoist point (49366) includes a portion of the mid-to-aft fuselage and attach fittings. This piece has heavy thermal erosion from the aft side evidenced by missing and melted collars

on the exposed fasteners.

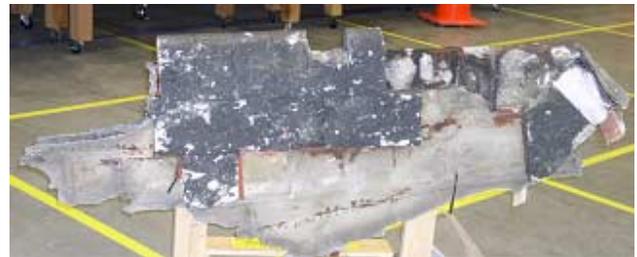
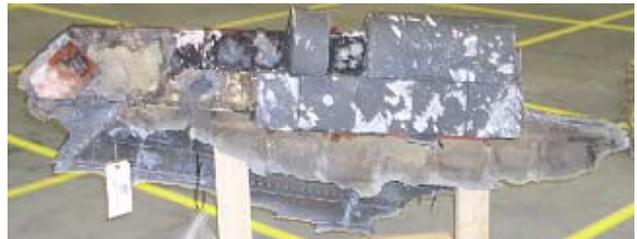
Item 52092

Two leading edge items have sections of left hand and right hand outer skin, the tip cap (1633) and the leading edge forward cover (52092). The forward cover has a prominent flow pattern in the upward direction at an approximately 60 degrees from the leading edge spar plane. Items lower on the vertical stabilizer show more signs of heat damage than items that are higher and aft.

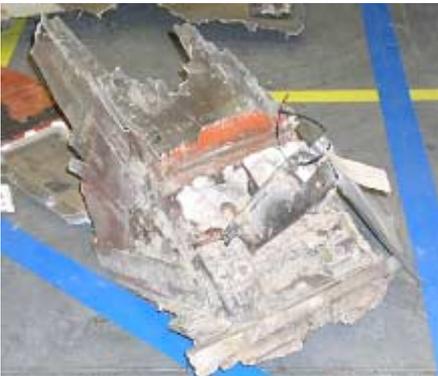
Item 2199

primary structural attach points between the vertical fin and the fuselage were recovered, the forward attach fitting (2199) and the right hand rear attach lugs with shear ties. The fractures occurred in the surrounding tail and fuselage structure and not with the primary attach bolts.

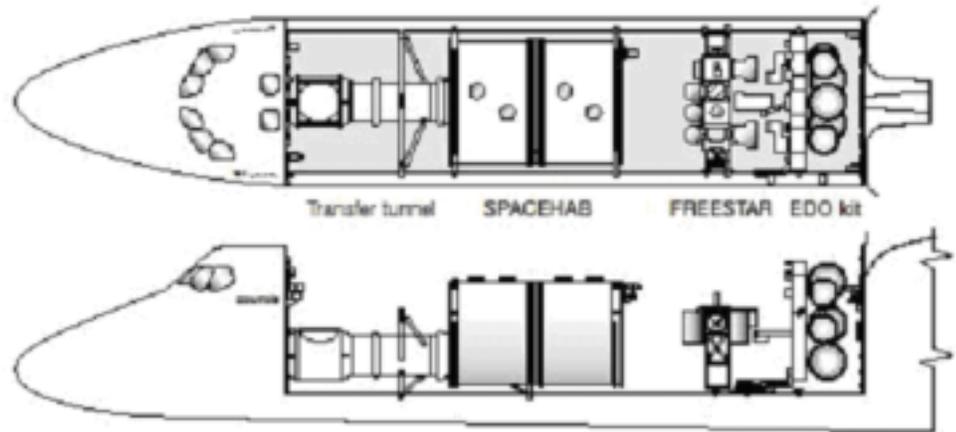
Several items have been identified from the tunnel assembly. The 7.87-inch forward tunnel section was identified nearly intact with the forward trunnion strut attach points and two partial struts attached. The ring for the forward flex section is attached but the rubber portion is burned adjacent to the ring and the opposite ring is missing. The portion of the tunnel that connected to the aft of this section appears to be melted and has

fracture surfaces. The rear strut attach ring of the tunnel was recovered with two partial strut sections attached. The upper strut attach bracket is torn from this flange leaving an incomplete ring. Another flex section ring with a partial thermally

degraded assembly was recovered but not positively identified as the remnants of the forward or aft flex section. One complete adjustable strut and several partial sections of struts have been recovered, as well as four trunnion assemblies and the keel assembly, each with partial struts attached. All of the tunnel assembly items recovered appear to have been exposed to extreme temperatures and heating effects.

(Note: the above picture is missing tunnel forward trunnions)

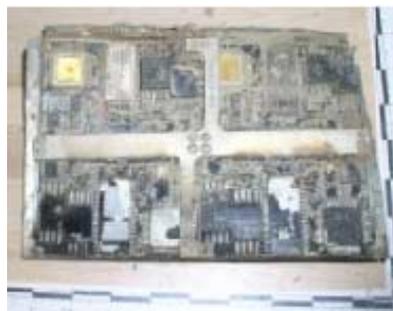
Item 44309

Most of the circuit cards (44309) were damaged from exposure to excessive heat. This damage was evident by missing solder traces, loose components normally held in by solder, missing components. In the most extreme cases the boards appeared to have been heated so much that the resin holding the fibers together, have burned away leaving charred, frayed material. Many of the circuit cards were also broken and only pieces remained.

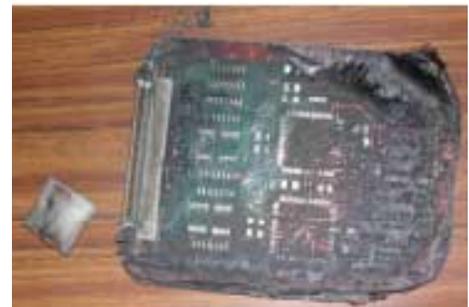
Item 15132

The LRUs in the aft avionics bays appear to have suffered from more heat and damage than those in the forward. No LRUs were recovered intact, and the cards from the advanced master event controllers (AMECs) (15132), aero-surface amplifiers (ASAs), ascent thrust vector control (ATVC) controllers, and cryogenic controllers were badly damaged. Identifiable LRUs were recovered, but in all cases they were missing their external skins and were identified by internal components.

The recovered LRU cases were heated to temperatures high enough to cause the aluminum to melt. Most part number, serial number, decals and other identifying markings on circuit cards were damaged or destroyed by exposure to high heat.

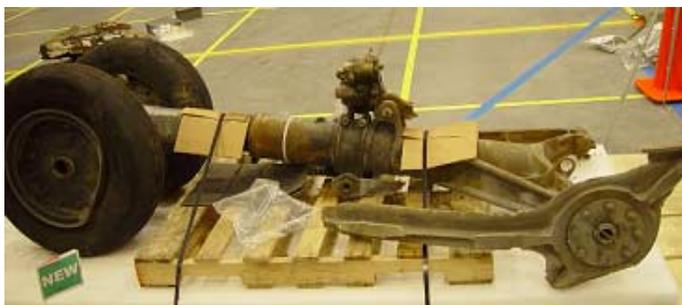
Item 9226

(9226) is intact to the point that hydraulic fluid was present and GN2 was almost at flight pressure after recovery. The nose wheel steering actuator has some heat damage. The left hand (aluminum) trunnion is still attached to the gear and the visible support ribs have high temperature web fractures. Both deflated tires are intact and attached to the wheels, which remain on the axle. The left hand wheel is intact and the right hand wheel is mostly intact, however, the inboard bead had broken free. Half of the fracture bead was recovered. The retract link tang is attached to the strut with about three inches of the link remaining.

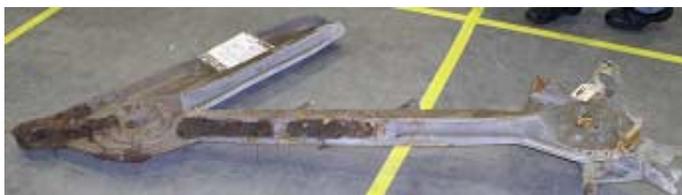
Item 565

The three remaining trunnions (565 and 2187) were recovered as two debris pieces. The main ribs between the trunnions are mostly intact and the webbing on the ribs shows a combination of heat effects and overload failures. Half of the door uplock cam assembly (1803) was recovered as well as several hinges

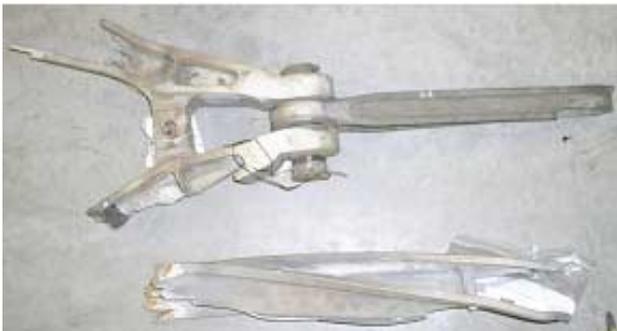
Item 2540/2218

for the doors. Only minimal evidence of thermal exposure is present. A large portion of the upper and lower drag brace assembly (2540 and 2218) was recovered. Both parts have broomstrawing and overload failures.

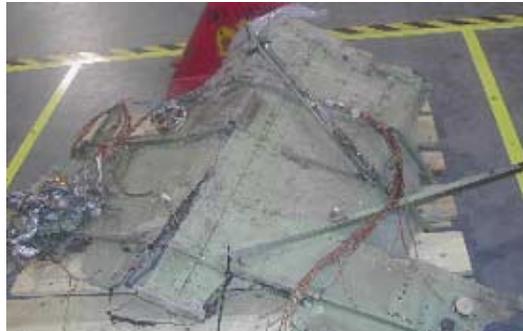
Item 561

Several pieces of the wheel well box structure were recovered and only superficial heat discoloration of the koropon is present. Parts of the uplock assembly were attached to these box parts and predominantly show evidence of overload failure. An example is item 561.

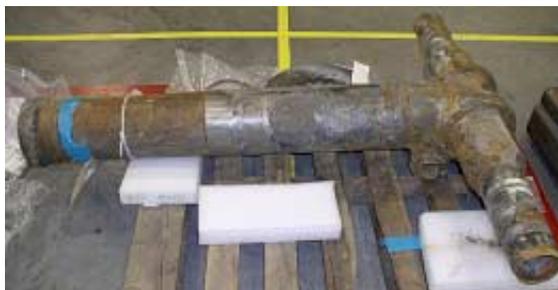
Item 1257

With the exception of the upper cylinder and the lower piston, only a small percentage of the left hand MLG was recovered. Most of the hardware shows signs of high temperature exposure. The lower piston assembly (1257) exhibited melting and thermal damage on the lower end. The outboard axle threads are gone with melted surfaces where they begin on the axle. There are burn through areas just aft of the jack pad and at the lower scissors mount. Both ends of the scissors mounting pin are melted. More than 95% of the bronze/aluminum portion of the upper end of the piston is missing. Sawtooth fractures and melting are visible. The piston barrel is in relatively good condition. The forward side of the piston barrel has much less chrome damage and less evidence of melting (bronze/aluminum material) than the aft side.

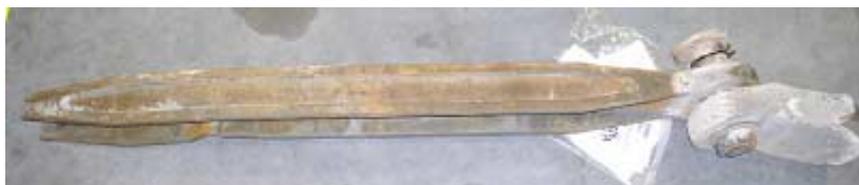
Item 24823

The lower drag/lock brace (24823) has minimal thermal damage. The upper pin and outboard mating clevis are still attached. The attached clevis piece, and the adjacent clevis piece (81992) recovered separately, are both thermally damaged. These two are the only aluminum parts recovered for the left hand MLG that is not protected by other hardware during flight. The lower end of the brace demonstrates a typical over-stress condition.

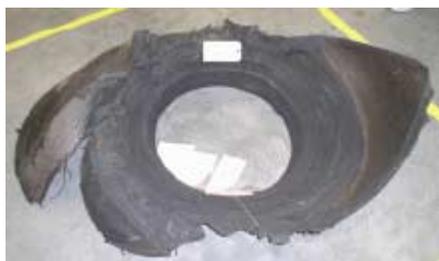
Item 197

The tires were recovered separated from any other structure. The left hand outboard tire (197 and 210) is split into two pieces around the circumference and directed heat is evident on the inboard side of the tire. The inboard tire (2168 most probable location) is in good condition with only minor thermal damage to the entire outer surface and a split in the body.

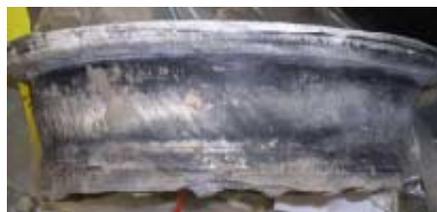
Item 567

The right hand outboard wheel (567) has a melted fracture surface on the inboard side of the wheel and the center portion of the wheel is missing.

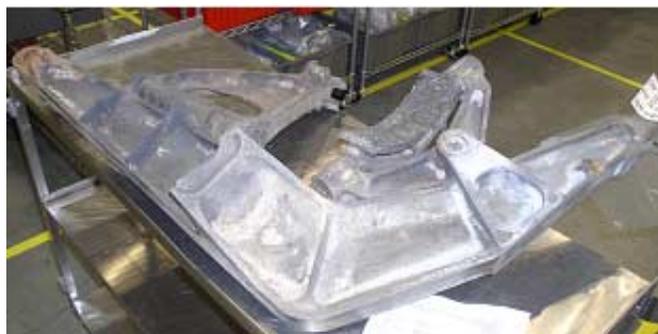
Item 84265

The MLG door retract actuator beam (84265) has some thermal damage as well, however, it is also mostly intact.

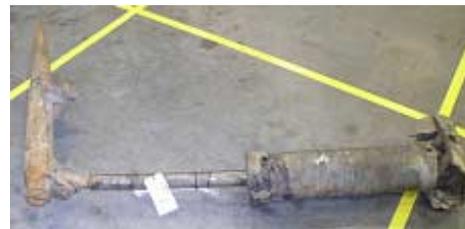
Item 27323

The gear retract actuator (27323) is intact and is attached to the upper portion of the landing gear. The gear portion has evidence of high temperature exposure. The down lock brace clevis fitting (45724) that attaches to the upper cylinder was

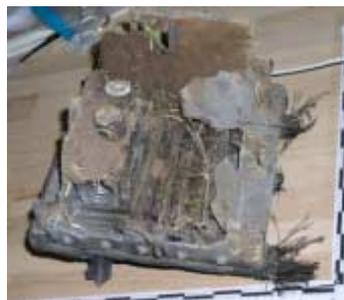
Item 6800

In the midbody, items recovered include Freon cooling loop hardware, aluminum cold plates (6800), accumulator parts (2029), and some cooling lines. The Orbiter has five gaseous nitrogen (GN2) tanks, all of which were recovered and identified. Most of the stainless steel vacuum vent and radiator Freon cooling lines were identified.

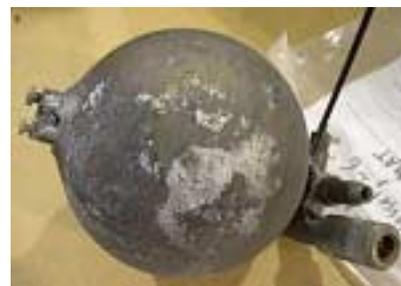
Item 59623

Auxiliary power unit (APU) – The APU propellant/GN2 tanks from systems 1, 2, and 3 (59623) were recovered. The tanks have moderate damage and all of the diaphragms are torn or detached from

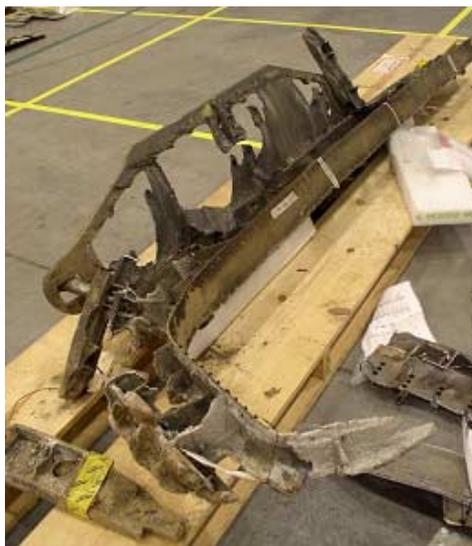
Item 266

Major components - Nine of the ten titanium longeron bridges (266) have been recovered and identified. Damage ranges from mechanical overload fractures, melted holes penetrating thinner flange areas, mounting hole galling, slag, and thermal damage. No damage trends are evident based on the location of this hardware in Orbiter. Eleven of the fourteen sill latches have been recovered, and have heavy damage similar to the longeron bridges. Two of the missing sill latches are secondary latches, and the third missing sill latch is part of the missing longeron bridge. All four of the keel bridges have been recovered, but only three of the keel latches were returned. The missing keel latch is torn off of the bay 3 keel latch.

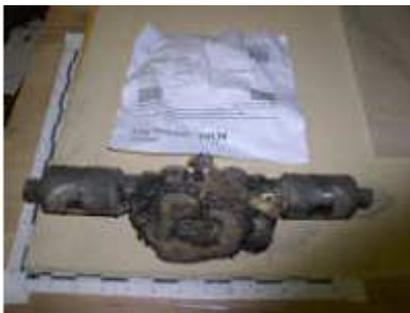
Item 16130

PRSD System - A hydrogen (H₂) T-0 valve and a fuel cell 1 (FC1) reactant valve (16130) were identified, both of which came from H₂ manifold 2. The left hand fuel cell oxygen (O₂) purge port was identified. Power reactant supply and distribution (PRSD) hydrogen relief 2 port was identified. The PRSD servicing panel (74847) behind door 45 was recovered. A few sections of PRSD plumbing remnants were identified through part marking or unique line insulation. Four Belleville washers, from two O₂ tank relief valves, were identified and have minor damage (internal to the relief valve).

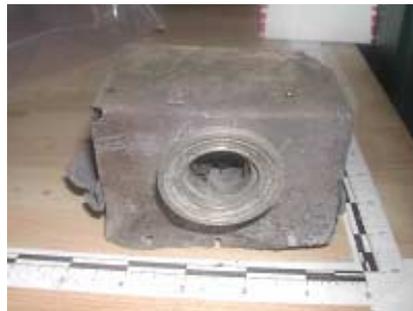
Item 10257

Several tank quantity probes and heater assemblies were identified. Several tank vacuum-ion pump converters (10257) were recovered, and some of them have thermal damage. The outer metal shell is removed from some of the recovered vacuum-ion pump converters exposing the internal components. One vacuum-ion pump (69490) was recovered with an intact magnet and exposed internal portion of the cathode.

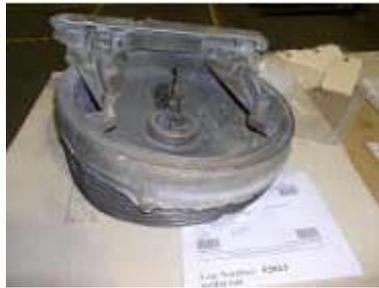
Item 52023

Potable & Waste Water Components
 - Portions of the potable water tanks (52023) and the waste tank (12055) were recovered. Some tank outer skin sections were also recovered. The internal bellows were separated from the outer vessel container. One supply water valve was found but was not identified to an exact location. The waste dump nozzle (8118) was recovered with part of the skin panel.

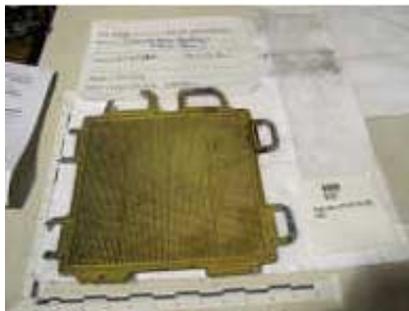
Item 8767

Fuel Cells - Fuel cell (FC) components were recovered with varying thermal damage. Approximately twenty of 288 internal cell reactant plates (8767) were identified and traced to their original FC. Several plates are nearly intact. Hundreds of small pieces of cell plates were also recovered but could not be identified.

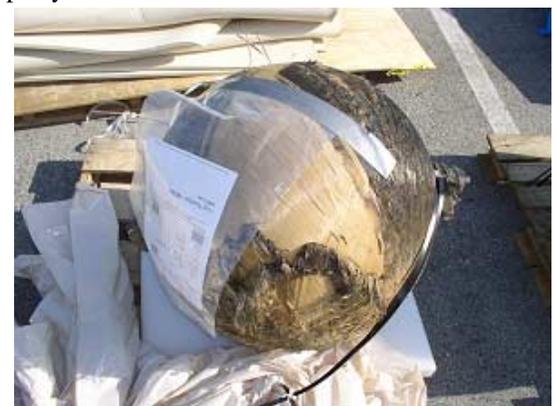
Item 49386

MPS components - The helium supply tanks (49386), which are made from two, forged hemispheres of titanium 6AL-4V alloy and covered with epoxy-impregnated Kevlar-49 fiber strands remained fully intact. The three 17.3 cubic feet and seven 4.7 cubic feet helium supply tanks were recovered and

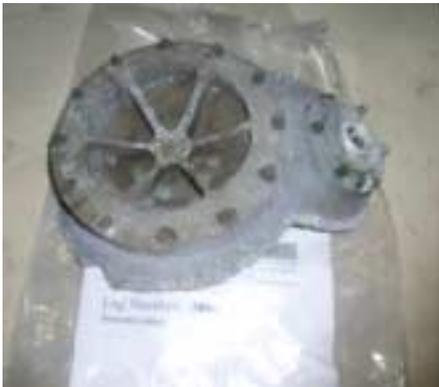
Item 56643

are charred and unraveled. No MPS valves, neither mono-stable nor bi-stable were recovered intact. All four of the fill and drain valve actuators, less the gear racks, were recovered, with the two LO2 valve (16931) visor blades still being attached to the actuators. Prevalve (56643) pieces were limited to housing flanges, anti-slam mechanisms, detent rollers/covers/belleville washers, visor/shaft assemblies, and actuator clutch/bearing assemblies. Mono-stable valve actuator internals such as pinion gears and gear racks along with housing flanges were recovered.

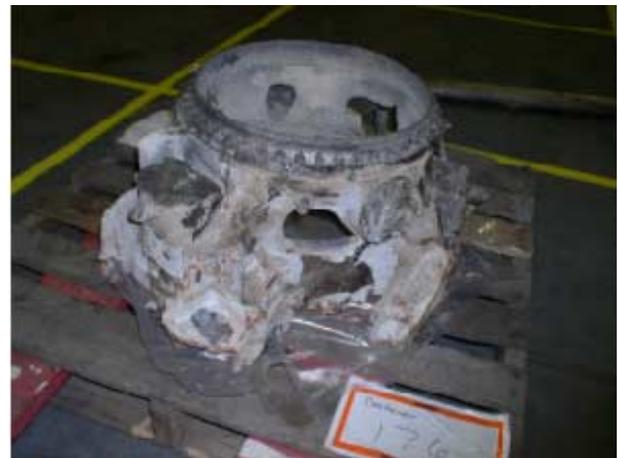
Item 22229

The Orbiter-to-external tank 17-inch disconnect housings (22229) were both recovered, but the associated ancillary tubing, drive arms, flapper valves, and latches are either missing or in various stages of thermal degradation. LH2 4-inch recirculation return system and gaseous oxygen/ gaseous hydrogen (GO2/GH2) 2-inch pressurization disconnect primary and secondary belleville springs

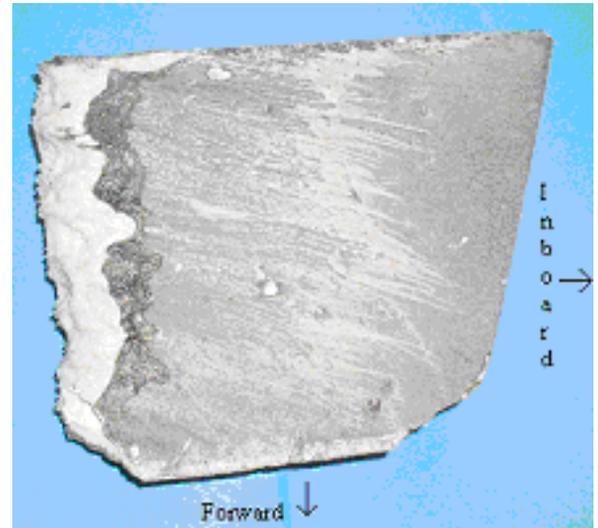
The LH main landing gear door tile on the forward outboard corner (identified as item 33590, P/N V070-191101-031) demonstrated a similar flow pattern as the left midbody panel (Item 283). Visual evaluation of the OML of the tile revealed apparent thermal flow erosion (melting, flowing and lifting of the RCG coating) of the outboard edge (directly adjacent to the outboard thermal barrier), with the flow direction inboard and slightly forward (Figure 9.1). This flow pattern was oriented approximately ninety degrees from the nominal flow direction expected in this area. In addition, the IML showed similar evidence of thermal flow erosion, but indicated the flow direction to be from inside the forward outboard corner of the main landing gear cavity, outward and forward. X-ray radiography did not detect any notable features aside from the

Figure 9.1. Left landing gear door perimeter tile, forward corner, item 33590

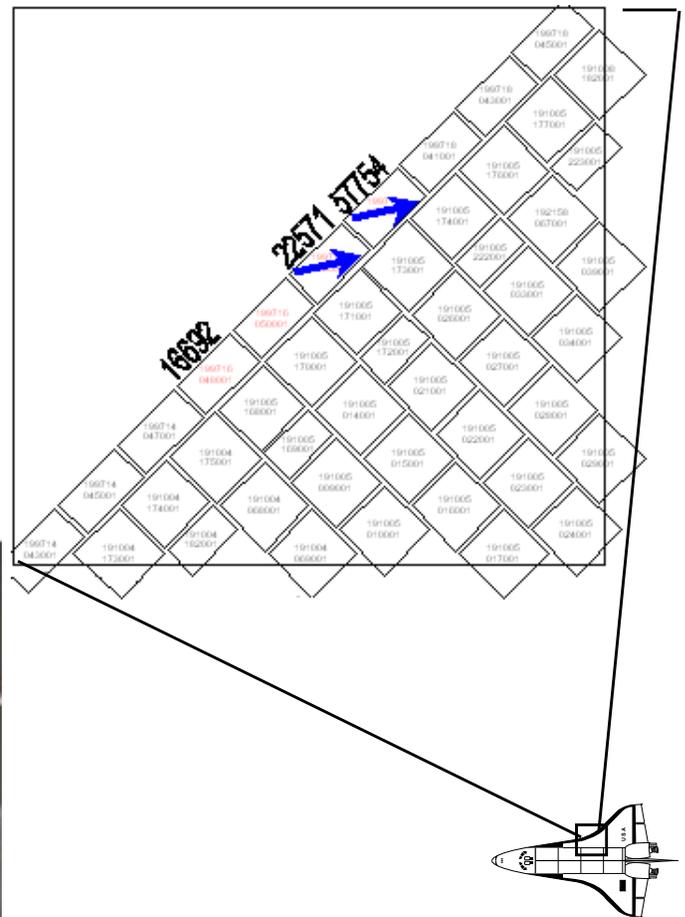
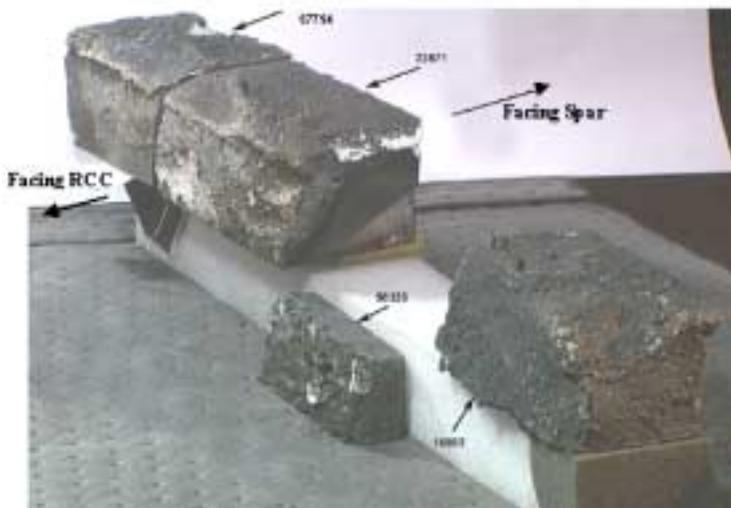
Figure 9.2. Reconstruction of recovered left hand lower LESS Carrier Panel 9 tiles.

Evidence of overheating and slumping was observed on three LI-2200 Lower Left Carrier Panel 9 tiles adjacent to left hand RCC panel 9. The item numbers of tiles are: 16692 (V070-199716-048), 22571 (V070-199716-052) and 57754 (V070-199716-054). Figure 9.2 shows the simulated configuration of the carrier panel tiles. Depressed/slumped and eroded regions were observed in two of the three tiles (Items 16692, 22571).

example, the forward-facing sidewalls of Items 16692 and 22571 that nominally seal against the lower RCC panel 9 heel were severely slumped and eroded.

Dark-colored deposits were observed on all three outer mold line (OML) tiles (Items 16692, 22571, 57754). The thickness of the deposits varied across the tile surfaces. In the case of 22571 and 57754, the deposits produced visually apparent flow-like patterns oriented in the aft/outboard direction (Figures 9.3 and 9.4). Visual evaluation showed evidence that in some locations on the tile sidewalls, the deposits had built up over adjacent soft goods. This was supported by the presence of entrapped ceramic fibers in the deposits.

One internal LI-900 tile originally located on Lower Left LESS Carrier Panel 9 was recovered. This tile (Item 50338, V070-194205-004) exhibited a heavily slumped and cratered appearance (Figure 9.2). An additional internal LI-900 tile was recovered from upper Left LESS Carrier Panel 8. This tile exhibited a greenish coloration and heavy slumping (Figure 9.5). The surface deposits on internal tiles 50336 and 50338 were not as thick as those

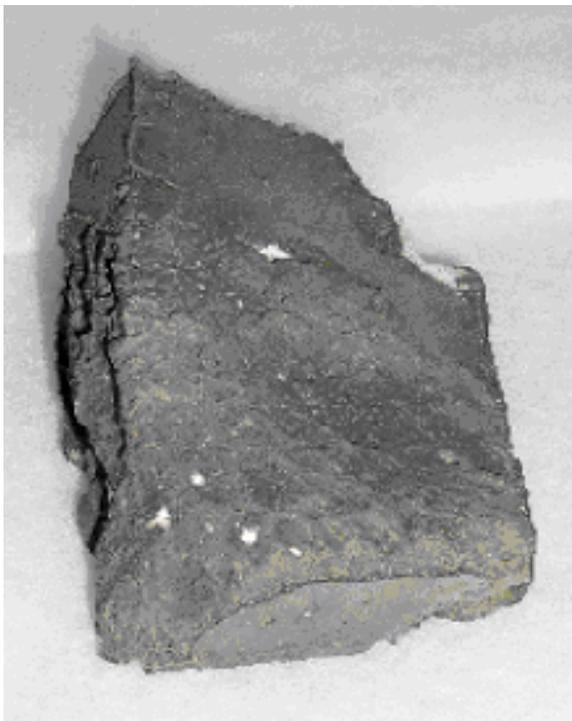
Figure 9.5. Upper left hand LESS Carrier Panel 8 internal tile (Item 50336)

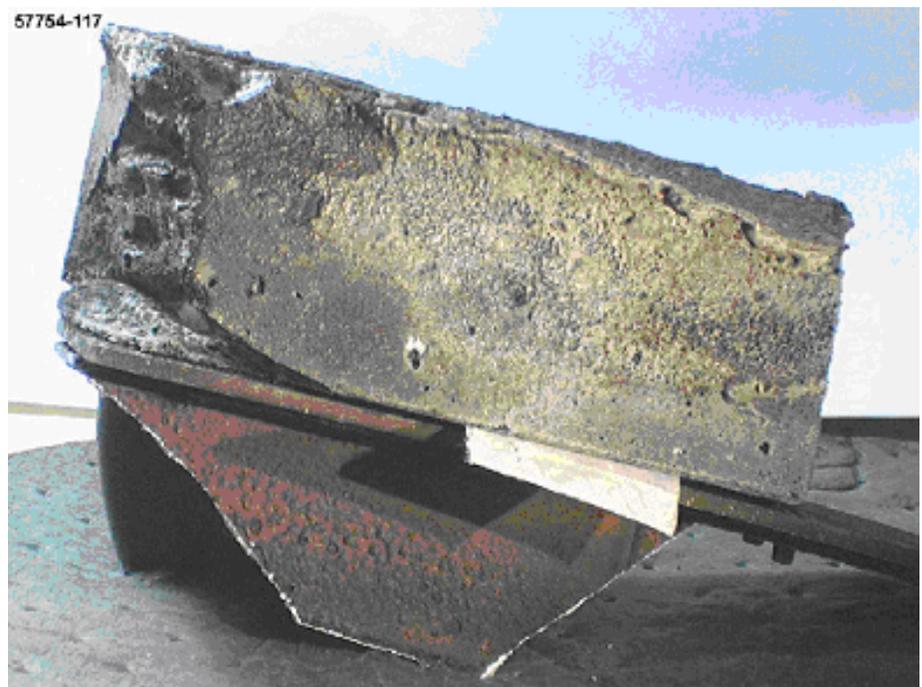
Tile item 57754 remained bonded to a section of underlying carrier panel 9 (Figure 9.7). Tile items 22571, 16692, 50338

Figure 9.7. Tile Item 57754 bonded to section of carrier panel

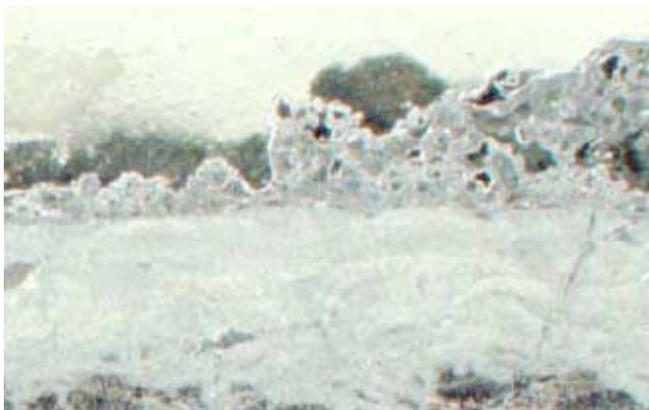
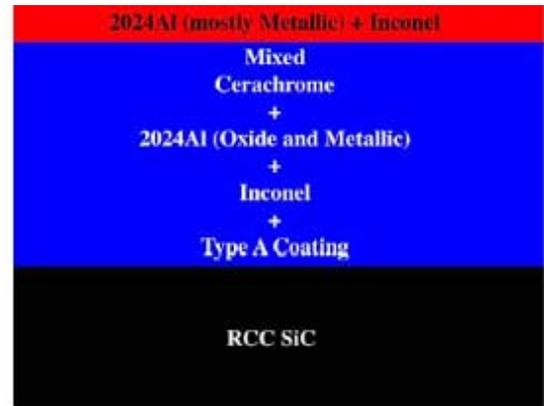
Figure 9.10. Cross-section of LH Panel 4 Lower Inboard (Item 80632)

1. Aluminum was detected in all layers of the deposits on the RCC Panels (Figure 9.10)

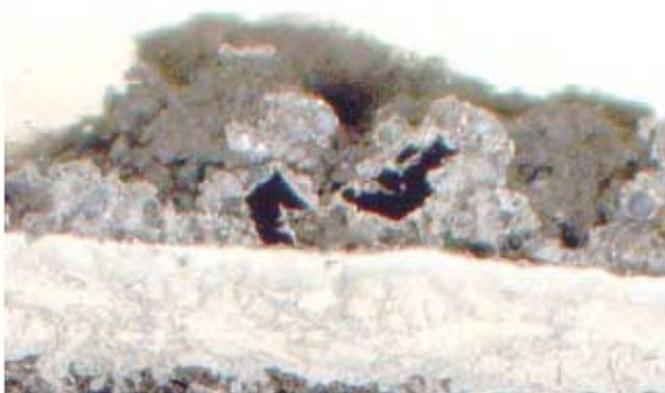
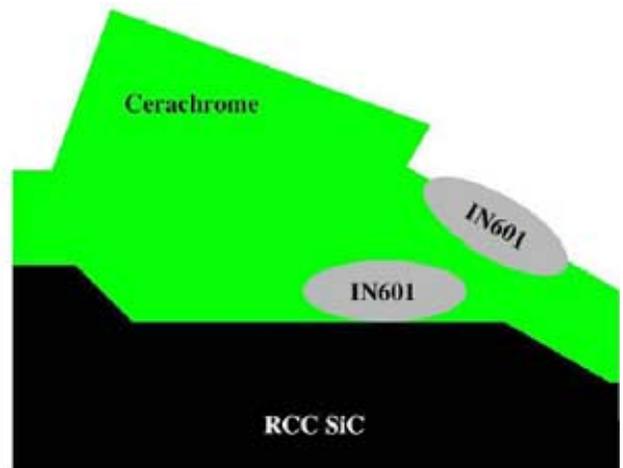
Figure 9.11. Cross-section of RCC Panel 4 Lower Inboard Rib (Item 80632)

2. Aluminum was not detected in the first deposited layer on the RCC Rib (Figure 9.11). This is unlike the observations of LHRCC panel 8 and is similar to LHRCC panels 5 & 7.

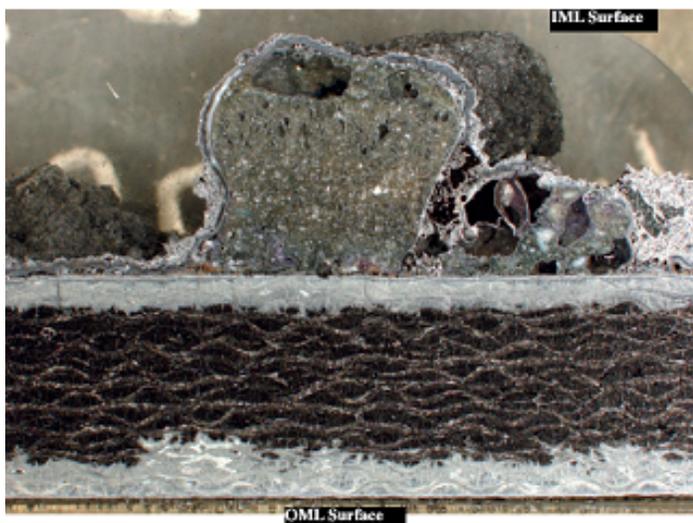
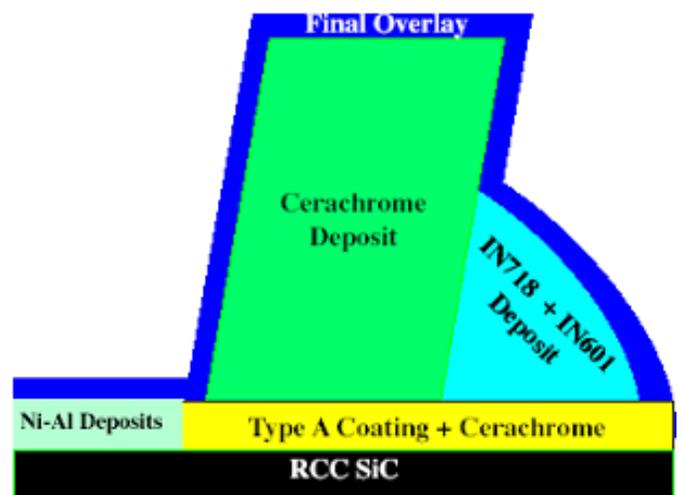
Figure 9.13. Cross-section of LH Panel 8 Upper (Item 43709)

1. Samples contained large amounts of molten Cerachrome mixed with metallic deposits of Inconel 718 and Inconel 601 (Figure 9.13)
 - Initially believed to be molten aluminum due to low density radiographic indications
 - Deposition temperatures exceeded 1760°C (3200°F), which is the melting point of Cerachrome)
2. Samples contained large spheroids of both Inconel 601 and 718
 - Consistent with melting of RCC

- spanner beam, insulator foils, and other RCC fitting materials
- 3. The first deposited layer contained both Cerachrome and Inconel but not aluminum
- 4. The final deposited layers contained heavy amounts of aluminum
 - Elemental composition was consistent with Al 2024 alloy
- 5. Deposits on the OML apex of Item 2200's fracture surface were molten Cerachrome with significant porosity, and some sodium and minor amounts of copper were observed
 - Indicates that the deposited Cerachrome was mixed in with Type
- Aluminum was in either metallic or oxidized form

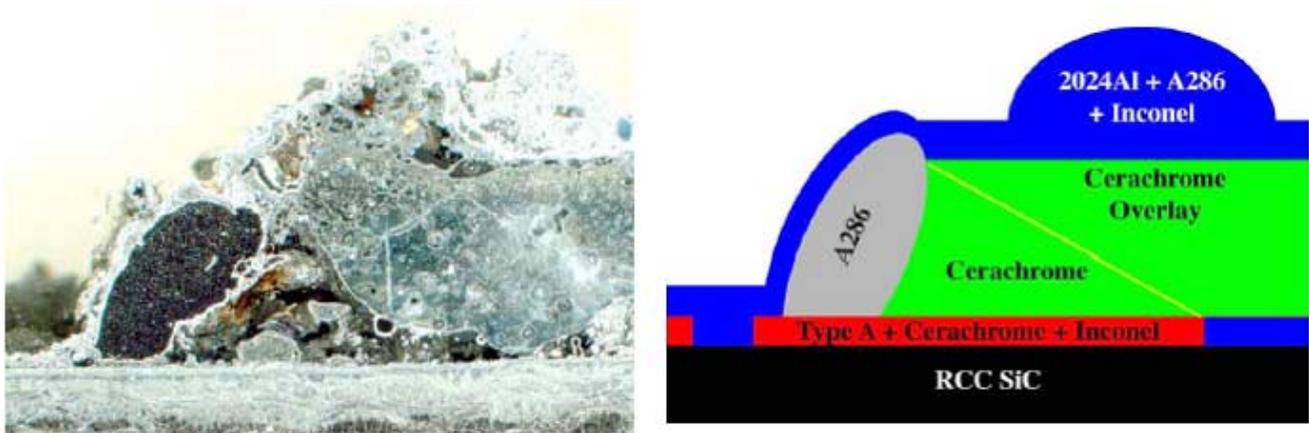
Figure 9.14. Cross section of LH Panel 8 Upper (Item 18477). The sample was removed near the inside of the panel's heel.

- A coating and Al 2024 spar material
 - No metallic components were detected, suggesting it either evaporated or flowed away with the plasma
6. A286 alloy was only detected in samples from Item 18477 at a location close to the spar fitting (Figure 9.14)

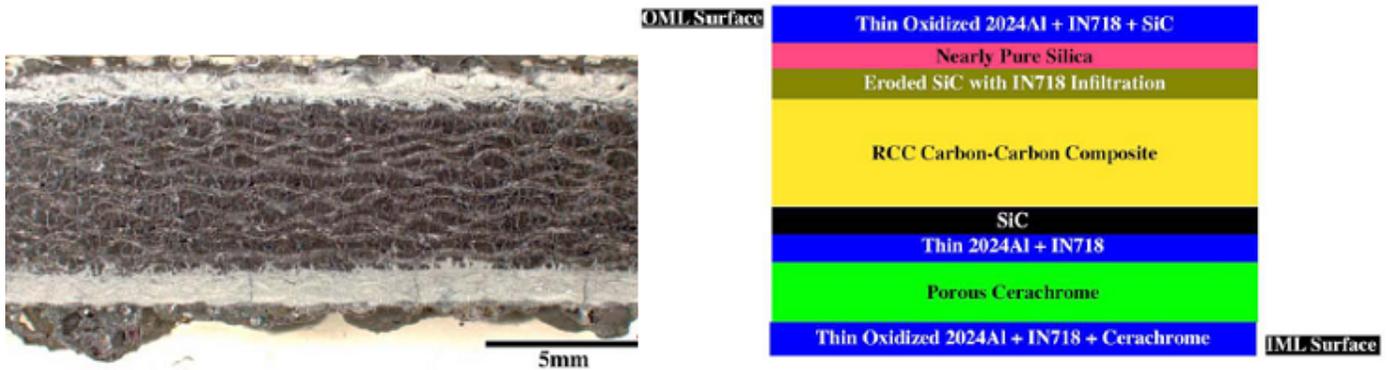
Figure 9.16. Cross section of Panel 9 Upper Rib (Item 7025)

- Erosion only detected on the OML of Item 7025 (Panel 9 Inboard Rib) (Figure 9.16)
4. Smaller quantities of molten Cerachrome were detected in the deposits relative to LH RCC Panel 8

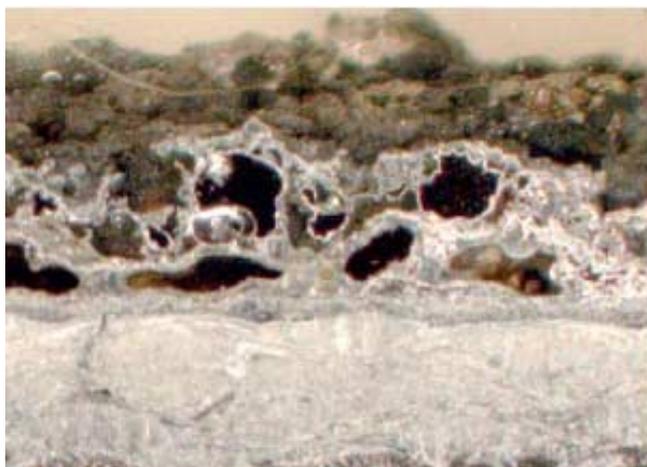
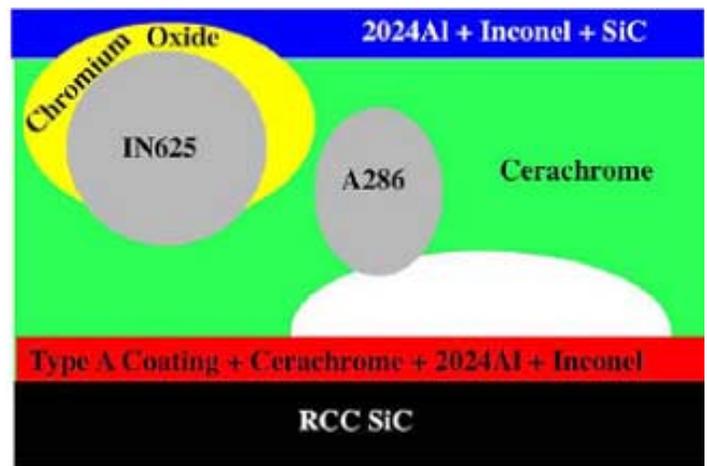
Figure 9.17. Cross section of Panel 9 Upper Outboard (Item 38223)

- Cerachrome was porous and contained less amounts of aluminum
 - Outer layers had less amounts of aluminum as a top layer
5. Samples contained spheroids of A286, IN718, and IN625 alloys (Figures 9.17-9.18)

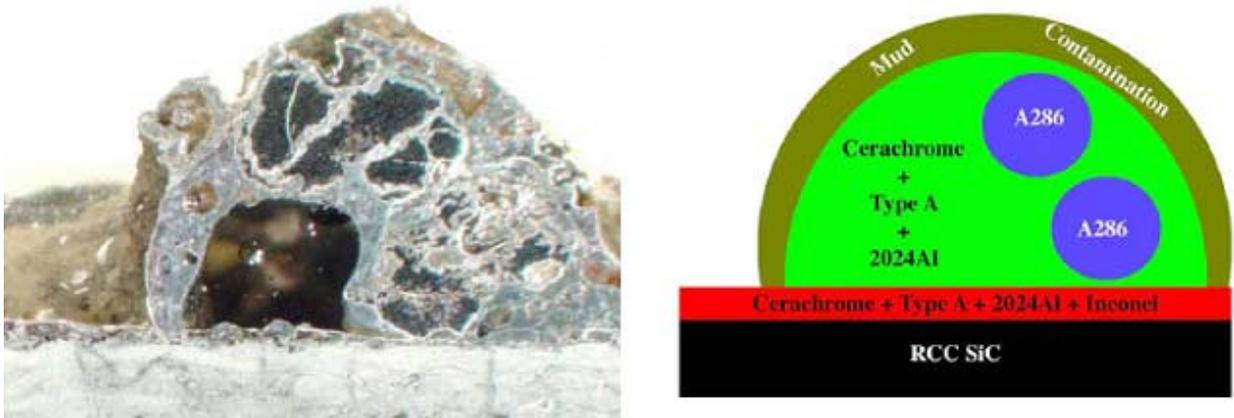
Figure 9.18. Cross section of Panel 9 Rib (Item 29741)

- A286 alloy was not detected in the first layers
6. There were less deposits on the IML of the Outboard Rib (Item 29741) than that of the IML of RCC Panel 8 (Item 61143)

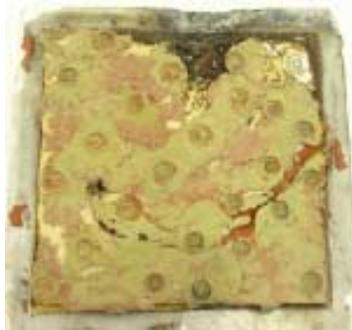
Backside Heating - Separation of tile from structure that occurs at the primer interface due to internal vehicle heating. Item 57481 shown

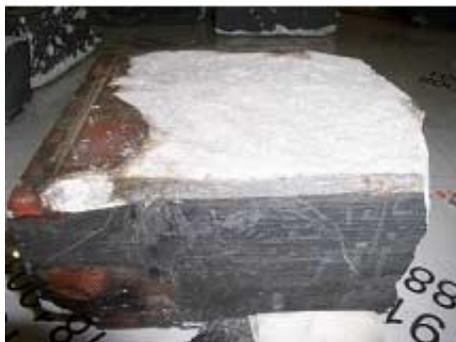
In-Plane TPS Fracture - Tile fracture

occurring about 0.10 inches above the IML just above the densified portion of the tile. Also known as densification layer failure.

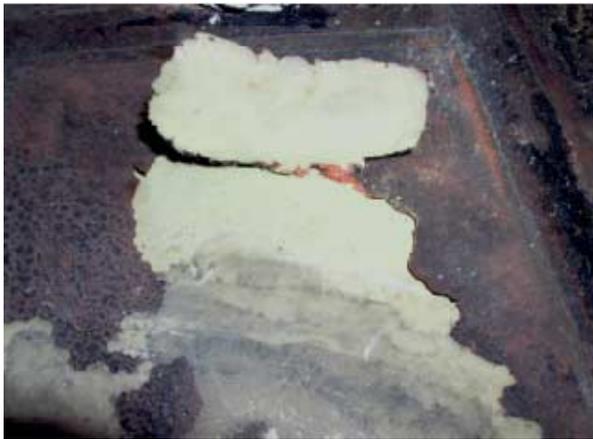
*Primer-to-
Primer Failure*

Primer-to-Primer Failure - Separation between two coats of epoxy primer, normally associated with back side heating. Item 283 shown.
